APPENDIX C3: PHOTOS

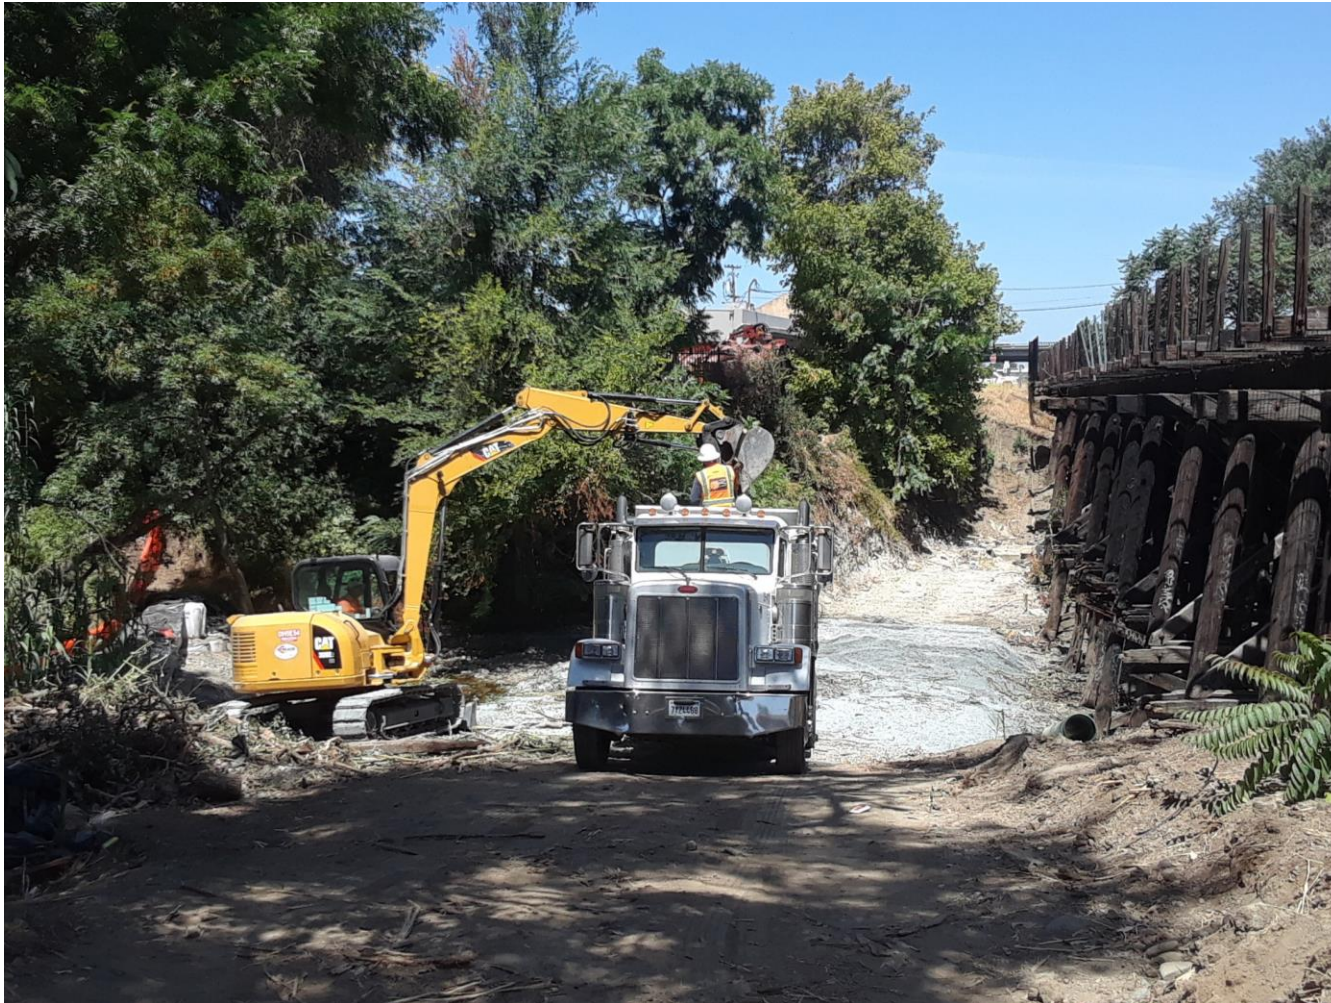
The Willow Glen Trestle across the Los Gatos Creek, viewed from the southwest, taken July 30, 2019. The Courts have granted the Willow Glen Trestle Conservancy an injunction which prevents the City from damaging the trestle itself, but that does not preclude the city's contractors from preparing to act: they have removed the nearby vegetation, created an accessway for heavy equipment, built a temporary dam and routed the creek through a 2-foot-diameter pipe, and "dewatered" the site. They are required to restore the creek to its natural channel by this Oct. 15th.

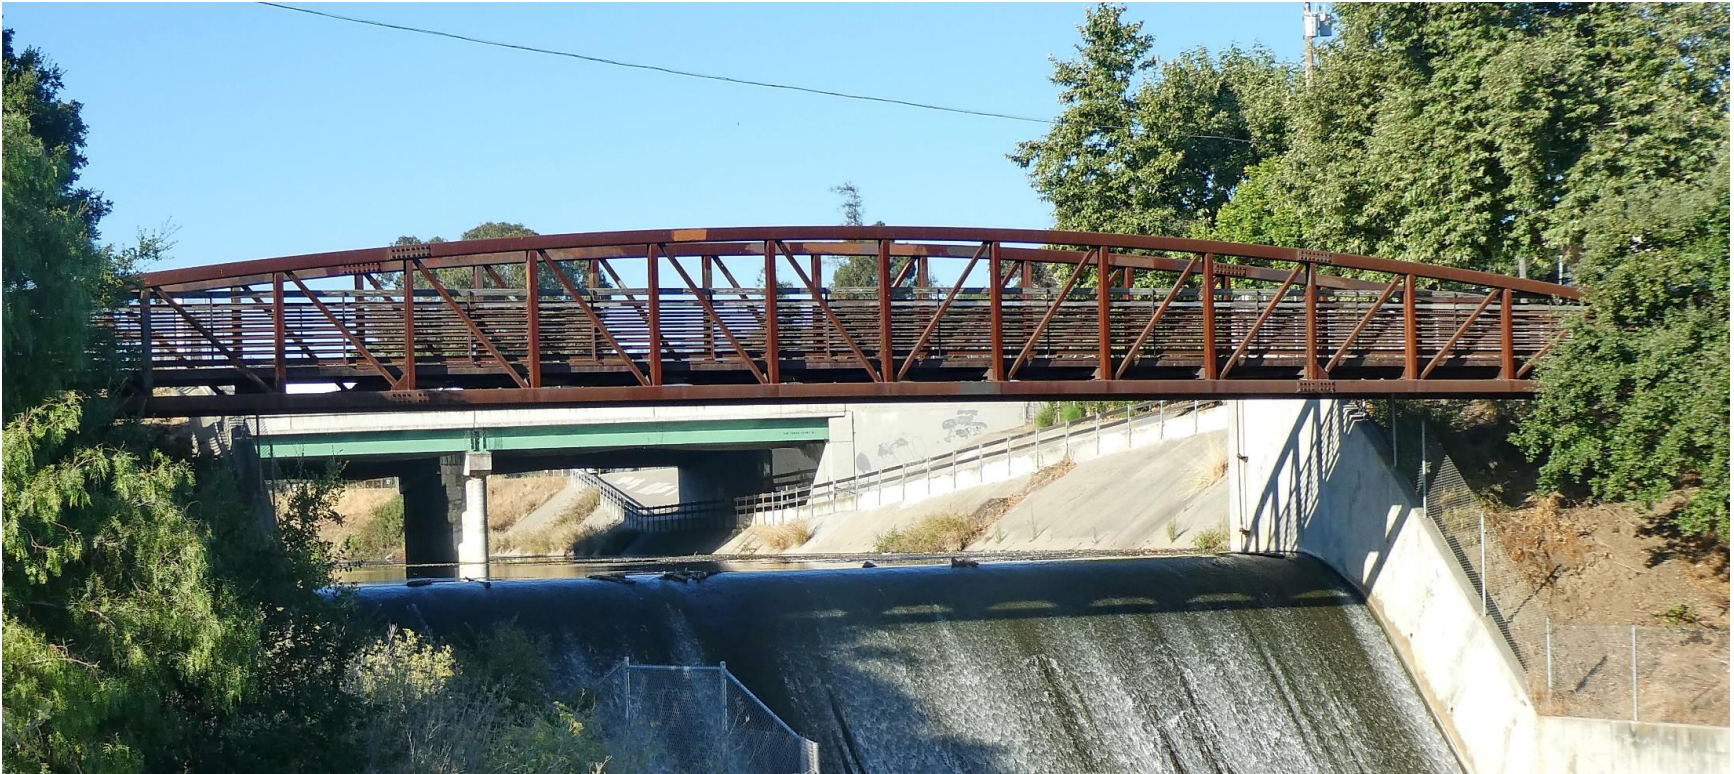
The Los Gatos Creek Trail by Camden Avenue in Campbell. The City of San Jose has bought a similar steel truss bridge, now in storage, that they seek to install in place of the Willow Glen Trestle.

If the city-purchased free-standing prefab steel-truss bridge *just has to be installed* at that site, is it necessary to first remove the trestle or could it just be left intact and in place? Without the need to carry the public or structurally support trail decking or anything else, could it be "just left standing"? The question to analyze: if the trestle abutments had to be removed to make way for the prefab bridge's foundation, would a free-standing and unburdened trestle be seismically safe and stable, or would the structure have to be tethered at the ends in some manner for stability? Again, perhaps a topic for a summer honors research study.

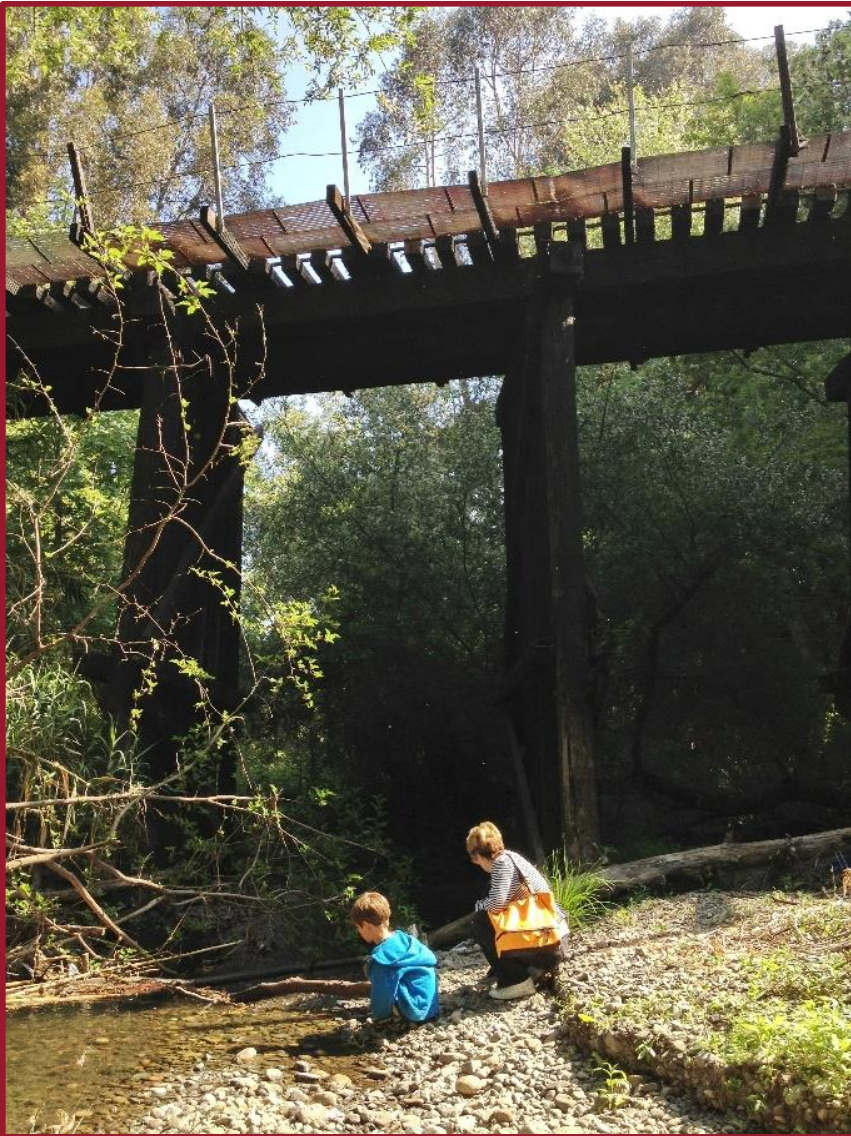
The Willow Glen Trestle remains standing and untouched.

The Los Gatos Creek is to be freed from its pipe by this fall.

The natural riparian (streamside) habitat will eventually recover, hopefully helped along with a revegetation and restoration effort.
