Case Number: 18CV335801

**DECLARATION OF DAVID VON
RUEDEN IN OPPOSITION TO
RENEWED MOTION FOR
PRELIMINARY INJUNCTION**

3 2. I am familiar with the Three Creeks Trail Pedestrian Bridge Project, which consists
4 of a contract between the City and Gordon N. Ball, Inc. ("Project"), under which Gordon N. Ball,
5 Inc. is responsible for demolishing the Willow Glen Trestle ("Trestle") in San Jose and replacing it
6 with a new single-span steel bridge. I have been CH2M Hill's (and now Jacobs's) project manager
7 for this project since 2012.

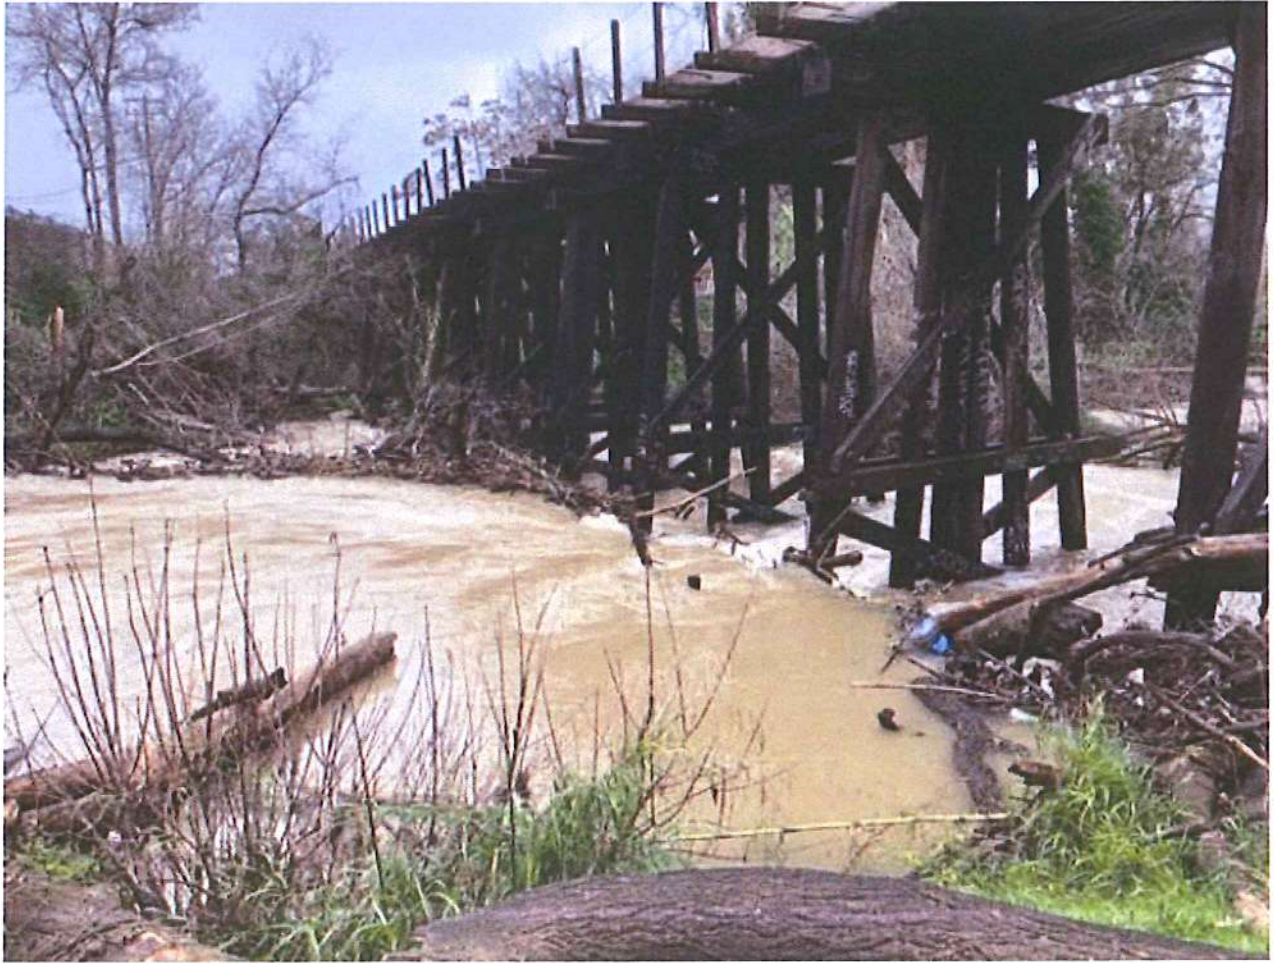
EXHIBIT A

4 7. Exhibit A depicts the debris load at the upstream side of the Trestle, which includes
5 large vegetation and trees. Though not visible underwater, stream flow conditions likely cause
6 erosion and scour at the existing timber piles. Piles are also subjected to battering from large debris
7 and hydraulic forces due to debris loading. This Exhibit also shows visible charring on the majority
8 of the Trestle supports (bents).

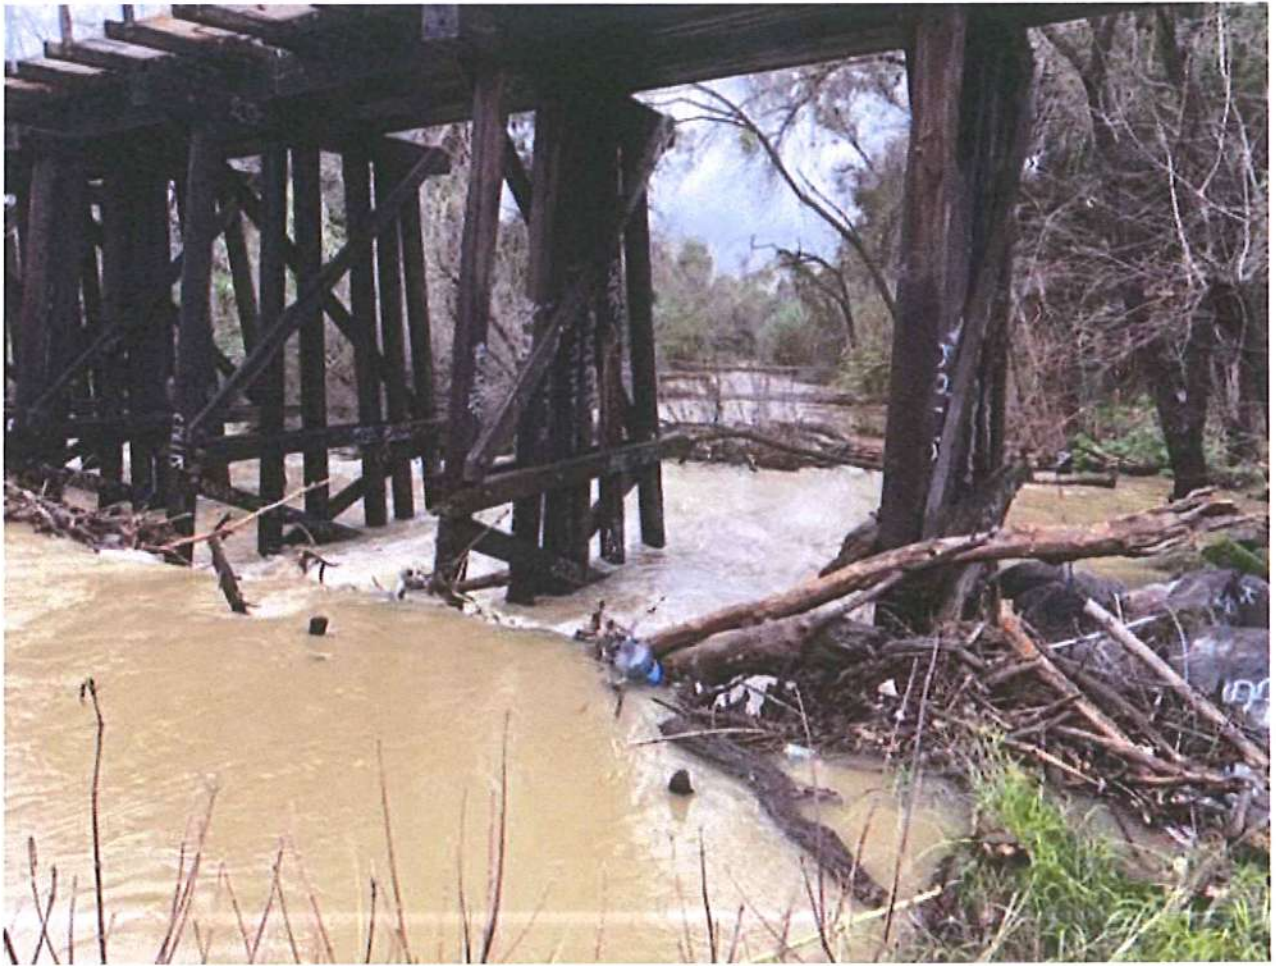
EXHIBIT B

9 8. Exhibit B depicts the Trestle piles and bents. Fire damage and graffiti are visible on
10 the piles; damaged and/or rotted timber bracing on the pile bents are apparent.

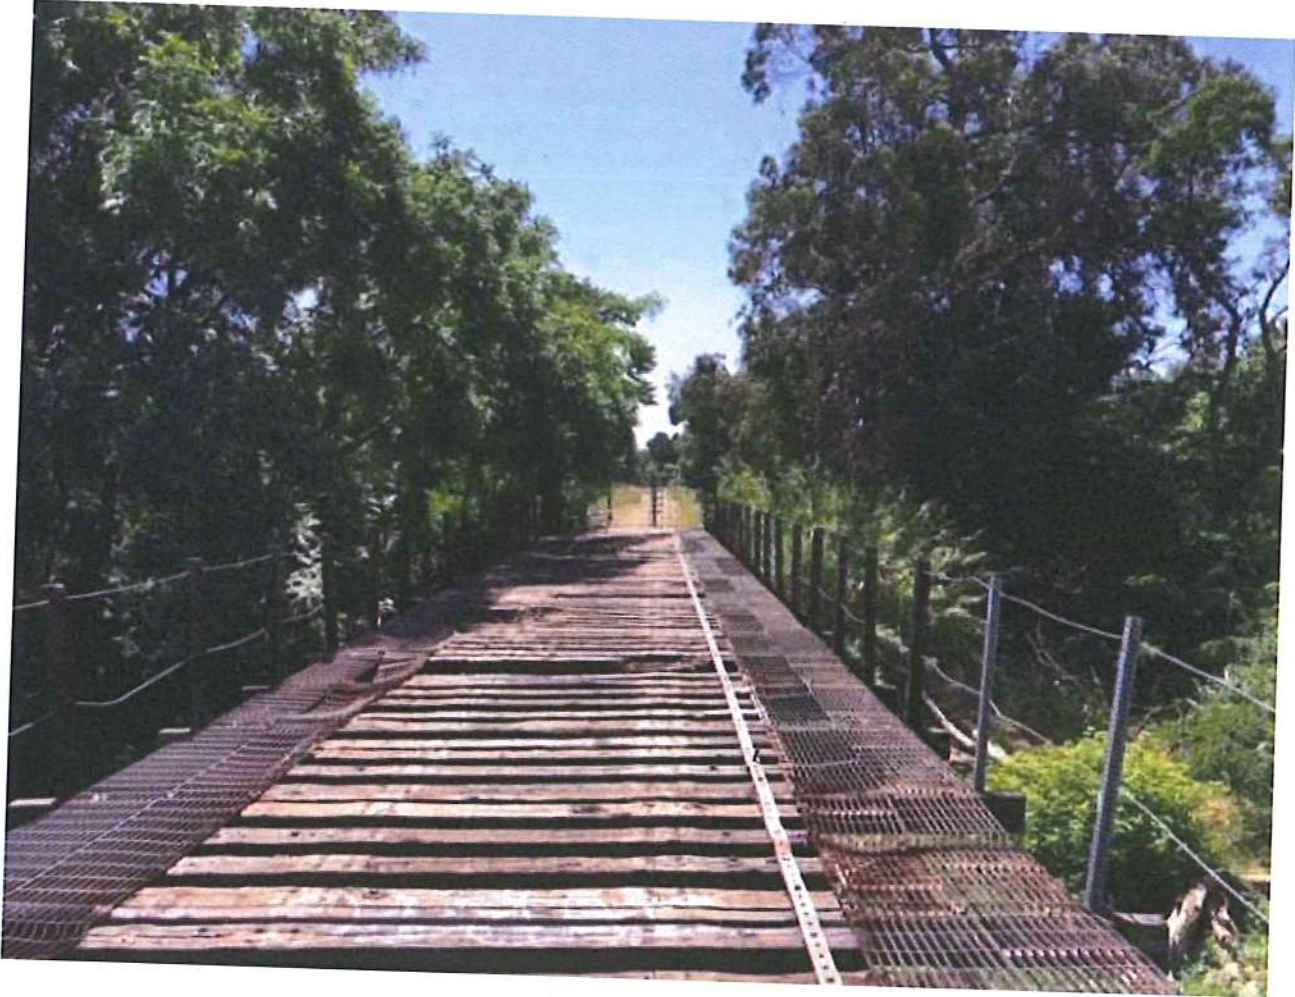
EXHIBIT D

17 11. Exhibit D depicts deteriorated ties, missing ties, bent and damaged railing posts, and
18 warped metal grates on the Trestle's deck.

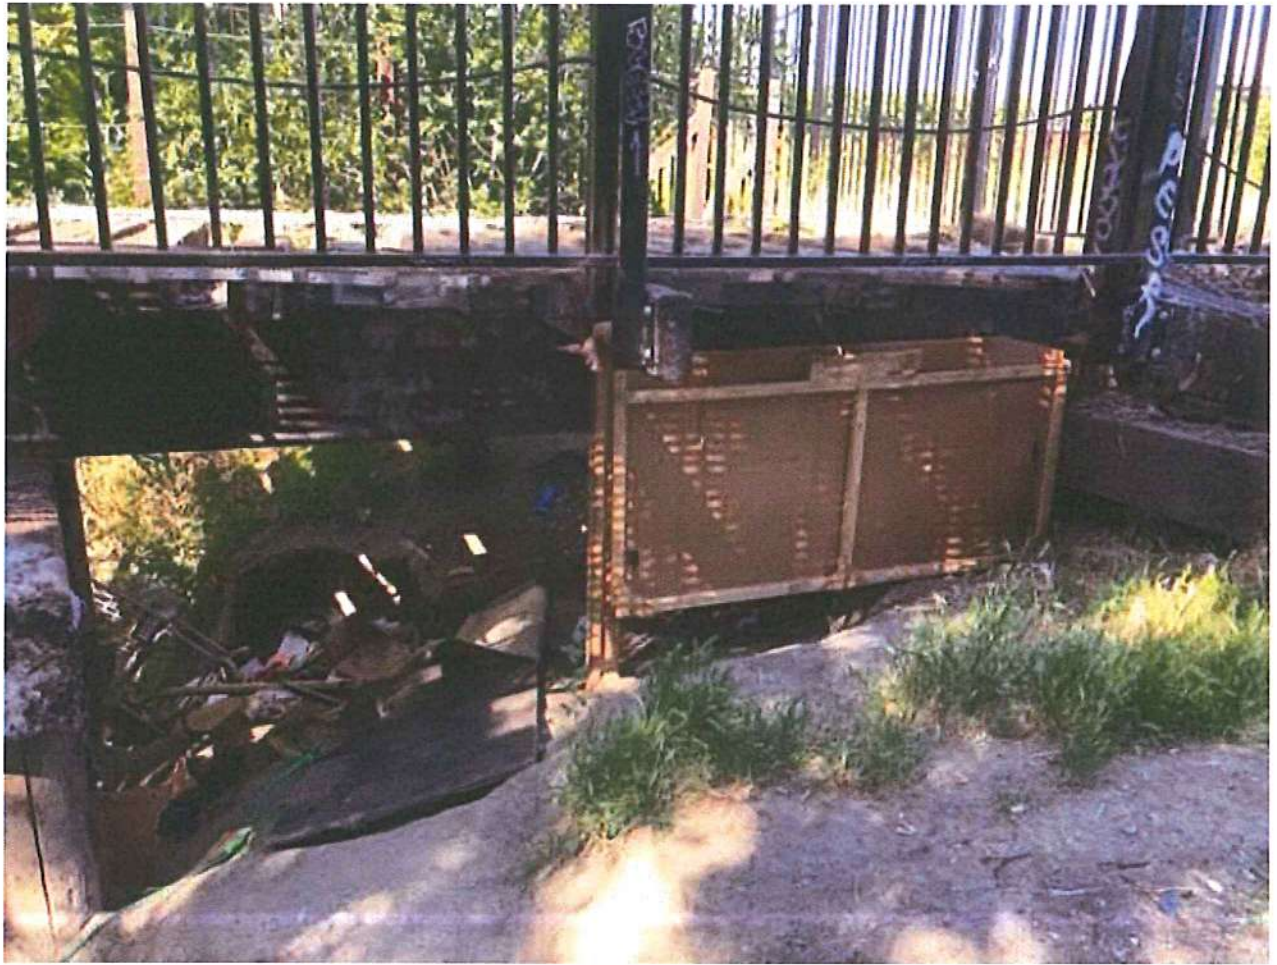
EXHIBIT G

1 15. Exhibit G shows the downstream side of the Trestle at the north abutment, and it
2 depicts vandalism, including graffiti on the Trestle's posts. It also demonstrates that the Trestle and
3 Creek bank area has been disturbed and impacted by homeless activity.
