re: Draft EIR, Three Creeks Trail Pedestrian Bridge Project, File No. PP13-085

I would like to submit the following questions and comments regarding the Draft Environmental Impact Report (DEIR) on the Three Creeks Trail Pedestrian Bridge Project (File No. PP13-085), which details the plans for the demolition of the 1922 Western Pacific Railroad Trestle across the Los Gatos Creek in Willow Glen (called the “Los Gatos Creek Trestle” in the DEIR and what we call the “Willow Glen Trestle”), and the installation in its place of a new prefabricated single-span truss steel bicycle/pedestrian bridge (the “prefab steel bridge”).

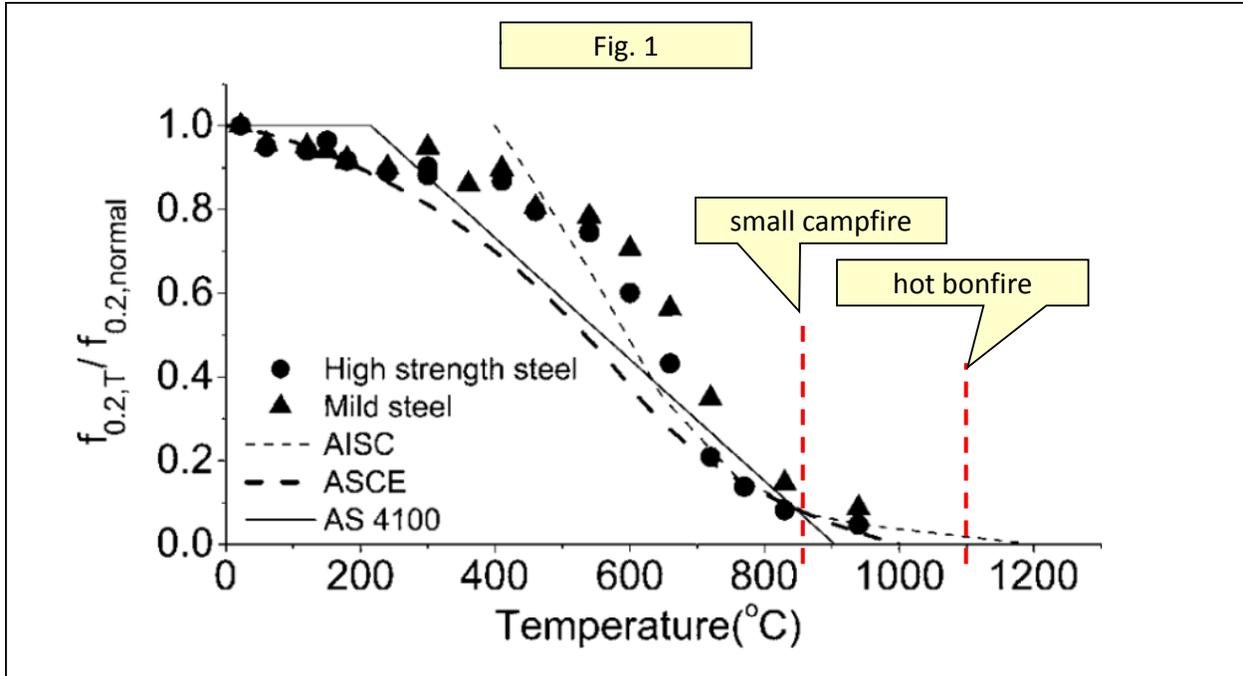
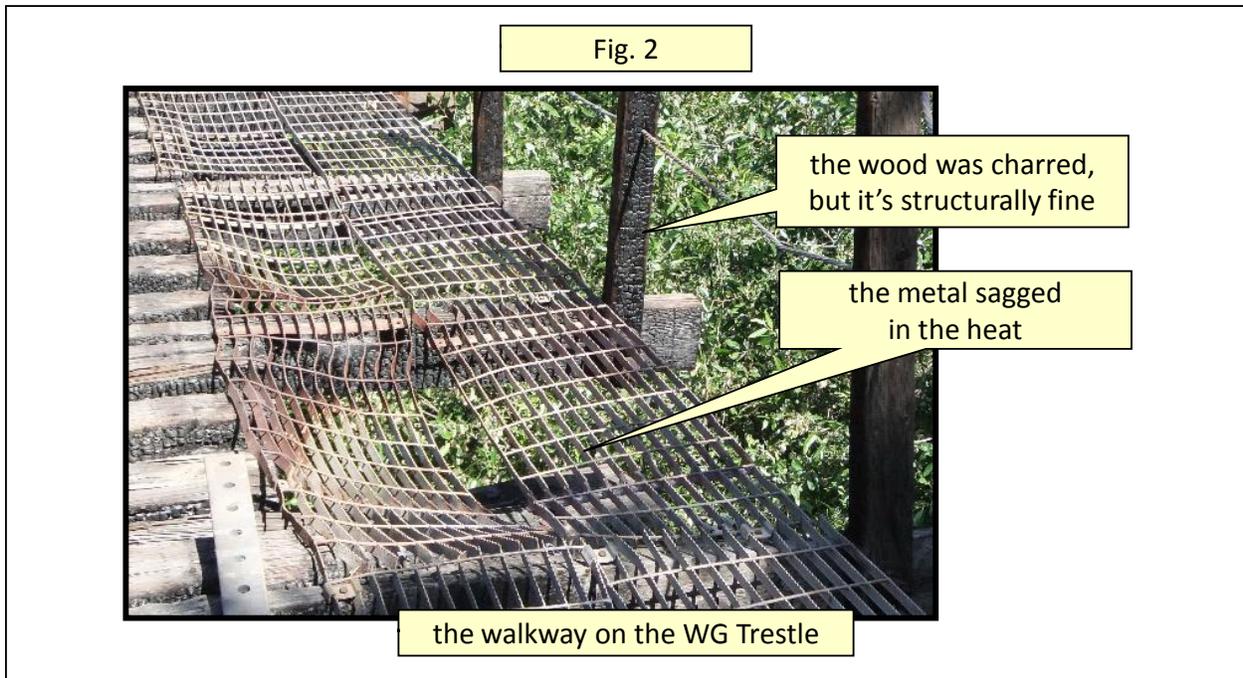
Fire does affect steel: when it gets above about 1,100 deg. F (600° C), it loses half its strength, and at 1,500° F (850° C – the temperature of a small campfire) it’s only a tenth as strong. A fire in a nearby clump of the invasive giant reed (*Arundo donax*, sometimes referred to as “bamboo”) could exceed 2,000° F (1,100° C), and the entire single-span bridge could collapse if any portion of the truss is compromised – which might require more than a “short-term closure” to repair.

This is not very esoteric knowledge: it can quickly be found with an internet search. For example, my Fig. 1 here is adapted from data found in a paper entitled “Behavior of high strength structural steel at elevated temperatures”, online at <http://ro.uow.edu.au/cgi/viewcontent.cgi?article=1345&context=engpapers>. It is information known to architects (I remember an architect explaining this to me decades ago) and to firefighters (I’m told that they have to have their ladders recertified if exposed to flames). Figure 2 is a real-world example: the metal walkway on the Willow Glen Trestle sagged in the heat of a past brush-fire, while the supporting wood timbers are charred but still strong.

Wood burns and steel doesn’t, but, as indicated by Fig. 1 and 2 above, steel can “yield” when excessively heated. The metal does not melt, but it does lose its strength, resulting in structures “buckling” (or “crumpling”, “sagging”, ...). This gives rise to a group of questions that need to be addressed by the DEIR:

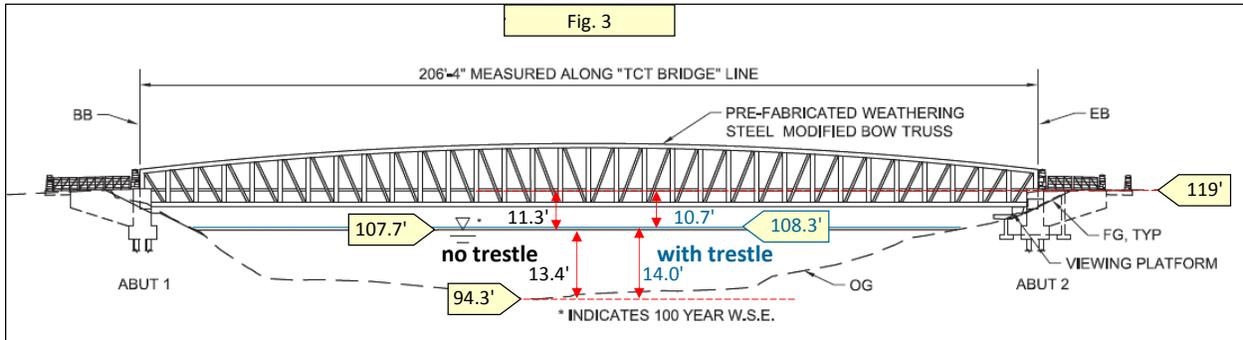
It would be quite helpful for the decision-makers if all this information were to be collected into a single graphic, perhaps by annotating DEIR Fig. 2.1 as shown here in Fig. 3:

- Table 3.9-2 in DEIR §3.9.3 (PDF page 77), titled “Summary of Hydraulic Effects under Flood Conditions”, gives model calculations of the “Water Surface Elevation” (WSE) in the case of a 100-year event at various locations along the stream. Just upstream of the trail crossing, the 100-year flood WSE under “Existing Conditions” (i.e., with the trestle in place) is 108.3 feet; and with the “Proposed Project” (trestle demolished), it is 107.7 feet: a difference of 0.6 feet, or about 7 inches. (Further upstream, at the Lincoln Avenue Bridge, the 100-year WSE levels are 109.8 and 109.5 feet: removing the trestle would lower the level of the water during a 100-year flood by about 4 inches. Downstream of the crossing, there is no difference whether the trestle stays or is removed.)

By combining these pieces of information from various locations within the DEIR, one can learn that the creek channel is 25' deep, and the 100-year flood waters are more than 10' below the top-of-bank: it is not a flood hazard. As summarized on DEIR page 3-48 (p. 78 in the PDF), “**hydraulic changes and flooding upstream or downstream of the project site would be less than significant.**” [Emphasis in the original.]

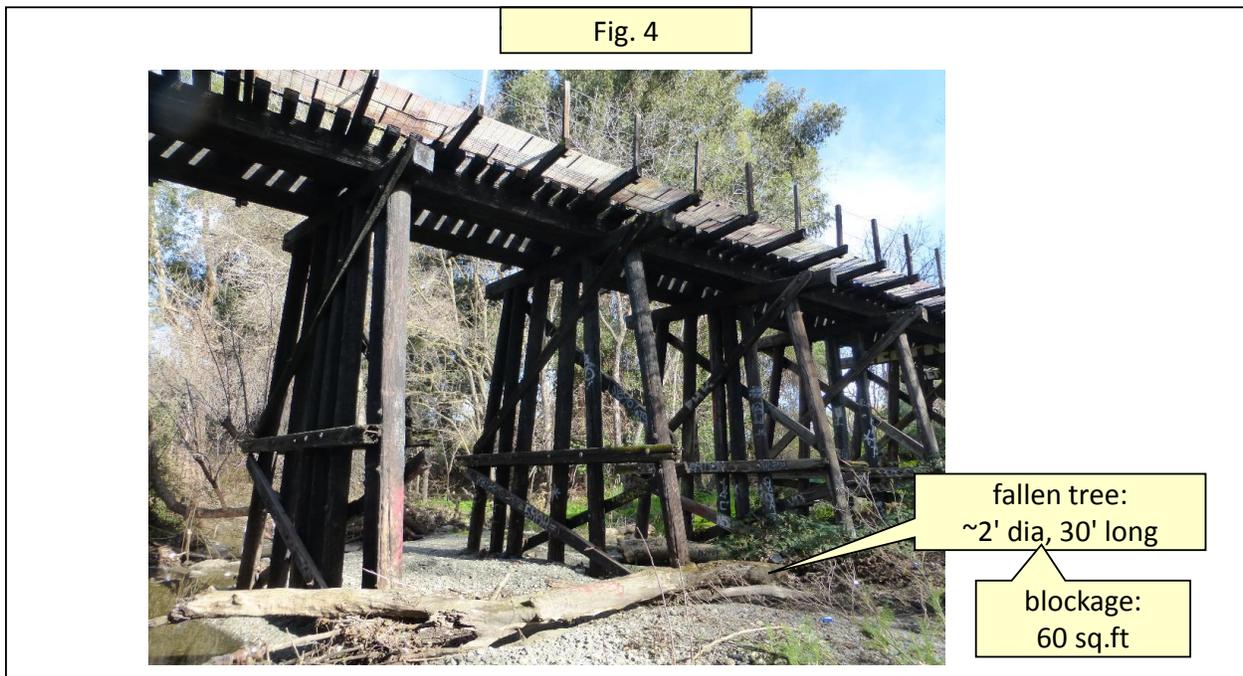
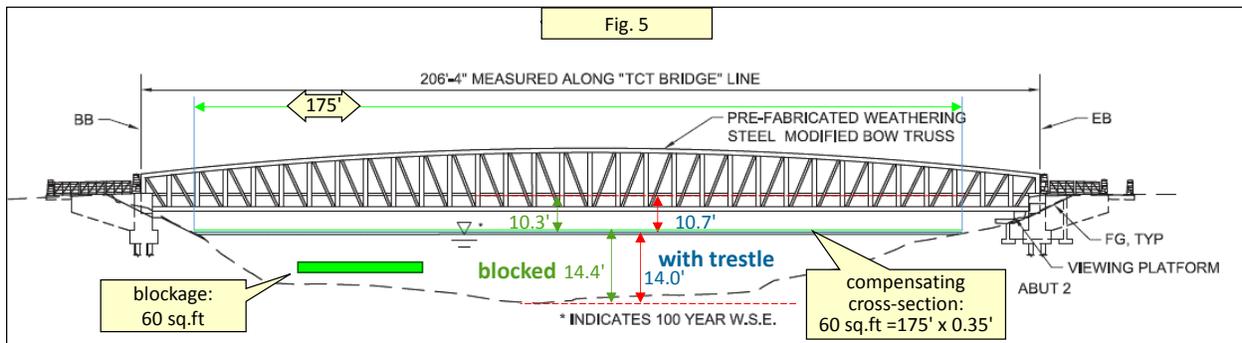
There has been considerable discussion about debris, such as large tree trunks, washing down the channel and becoming snagged on the trestle piles (see Fig. 4), thereby blocking the flow of the creek. It is straightforward to estimate the impact such logs might have:

- Estimate the typical diameter and length of a log: say, 2' in diameter and 30' long, and then multiply them together to find the cross-sectional area: 60 sq.ft. in this case.
- To first order, the water level will rise to compensate for the blocked cross-section. From Table 3.9-2 in DEIR §3.9.3 (PDF page 78), note that the “top width” of the creek during the 100-year flood event is about 175'. As shown in Fig. 5 below, to make up for the 60 sq.ft. blocked by the log, since $0.35 \text{ ft.} \times 175 \text{ ft.}$ also equals 60 sq.ft., the water level would rise by about 0.35 feet – approximately 4 inches.

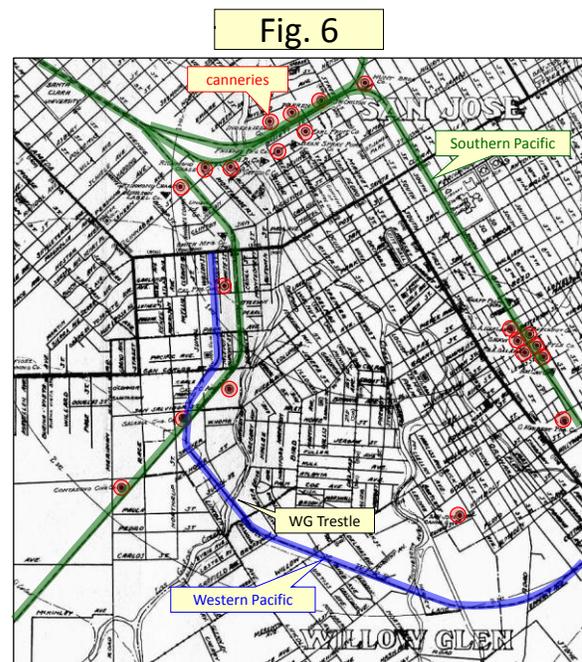
- Page 11: “One category, particularly apropos for the San Jose area, was ‘dried fruit.’ ” But the trestle was built so that Western Pacific would be able to serve the canneries: statistics on canned good would have been more relevant. (Figure 6 is the 1934 Polk San José City Directory map, where I’ve highlighted the canneries in red, the SP tracks in green, and the WP line in blue.)

- Page 12: the report provides lots of statistics for the shipping of dried fruit. The consultant asserts that, since Western Pacific (WP) only shipped 5 to 10% of the amount that Southern Pacific (SP) shipped, it follows that Western Pacific was not relevant. Looking at the map in Fig. 6, it is apparent why: SP served more canneries than WP. That doesn't mean that the WP wasn't important for the canneries that it did serve. Additionally, sometimes all it takes is the threat of competition and a 5% market share to shake up an industry – just look what Apple Computers did with IBM!

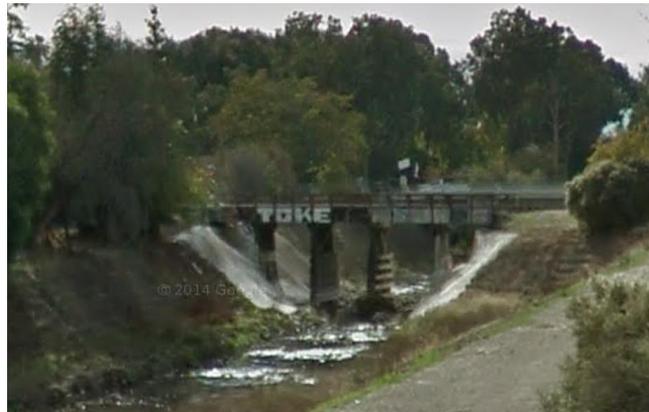
- Page 13: the “common presence of timber trestles”. Okay, so trestles are common. Many of them are simple structures, like that shown in Fig. 7 (this is the third trestle on this railroad spur, where it crosses Silver Creek), whereas the Willow Glen Trestle is quite scenic and is quite tall for a simple “pile-and-cap” structure. Also, many trestles are still in use by the railroads, and many are in remote areas: not accessible for public enjoyment and enlightenment.

- What is the height of the tallest still-standing “pile-and-cap” wooden trestle in California? Is it in good condition? Can it be readily incorporated into a regional trail?
- How many wooden train trestles were built in San José?
- How many wooden train trestles remain in San José?
 - (1) The Willow Glen Trestle,
 - (2) its “sibling” over the Coyote Creek (which would “bookend” the Three Creeks Trail and connect it to the Five Wounds Trail)
 - (3) their “poor cousin” across the Silver Creek (Fig. 7 above)

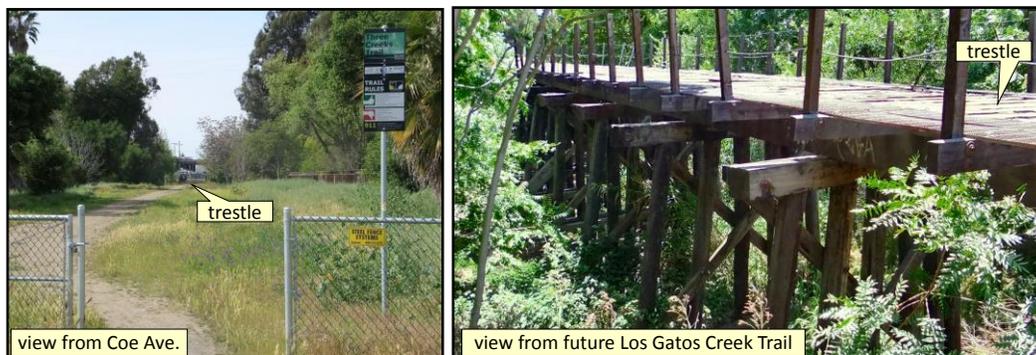
It’s true that the trestle is “not easily viewed” from Coe (see left side of Fig. 8 below). However, the DEIR doesn’t discuss the view from the future extension of the Los Gatos Creek Trail, which is shown in DEIR Fig. 4-1, on page 92 in the PDF.

The right side of Fig. 8 shows the view of the trestle from the future trail from downtown San José. The 1920’s trestle would give a fitting welcome to the 1920’s-era community of Willow Glen, a community whose very existence as an independent town in the 1920’s is due to the impact of the railroad. Would a new pre-fabricated steel-truss bridge be more representative of the character of the Willow Glen district?

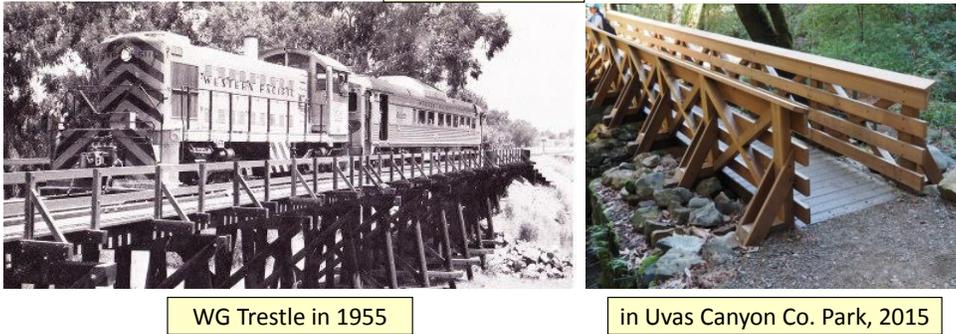
Fig. 9

In the DEIR, Figure 6-1 shows a rendering of a possible retrofit: the drawing is devoid of all soul. Fortunately, as noted on p. 6-1 (PDF p. 97), *“If bridge retrofit is selected as the preferred alternative, then additional refinements could be made.”* Figure 9 (below) shows what the Willow Glen Trestle looked like in 1955. Next to it is a pedestrian bridge recently built in Uvas Canyon County Park: sturdy, environmentally responsible, and quite reminiscent of the trestle in 1955. Hopefully, the trestle will be saved, and the community can consider a variety of such design options.
